Disaster prevention of historic buildings and townscapes

— Consideration of earthquake resistance measures in particular —

KARIYA Yuga

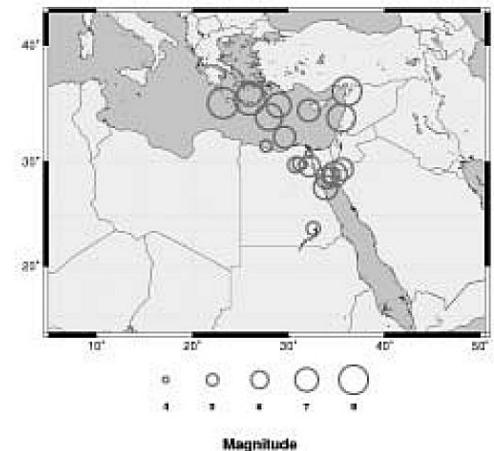
図一 1 エジプトにおける被害地震の分布図。紀元前2200年から2005年まで

Distribution of Damaged Earthquakes in Egypt. From 2200 BC to 2005.

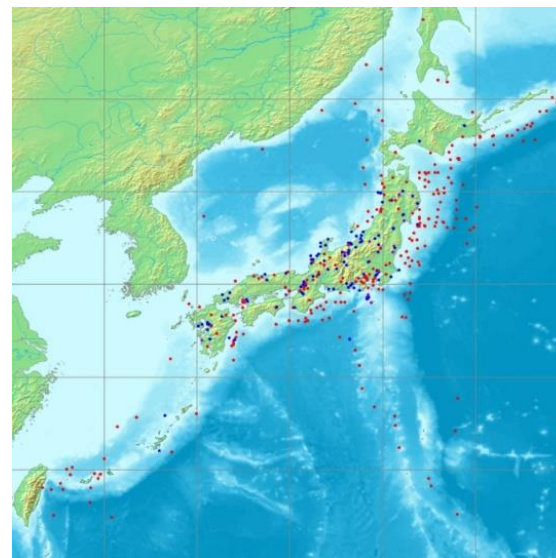
Epicenters of major earthquakes in Japan in the past.

Red: M7 or higher, Blue: fatalities, Purple: maximum intensity 6 or higher.

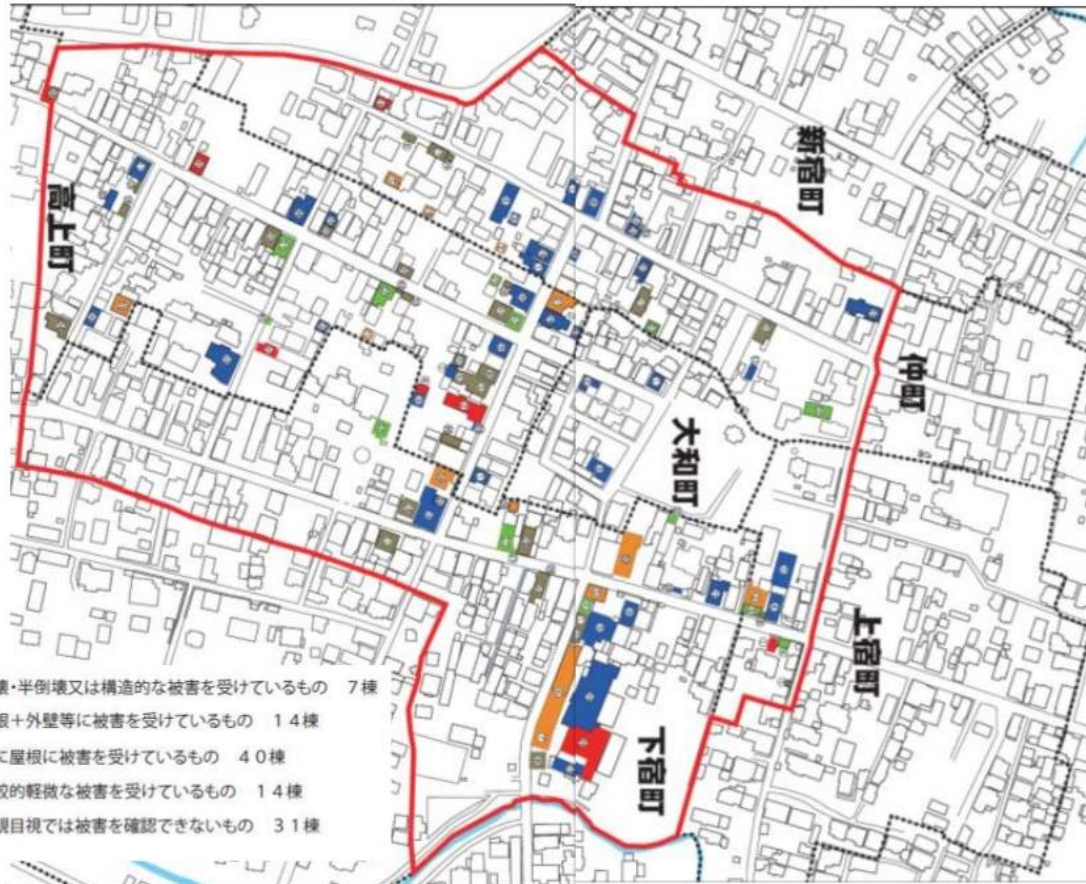
特定建築物の被害分布

- Extent of the Preservation District.
- traditional buildings

Distribution of the damaged traditional buildings

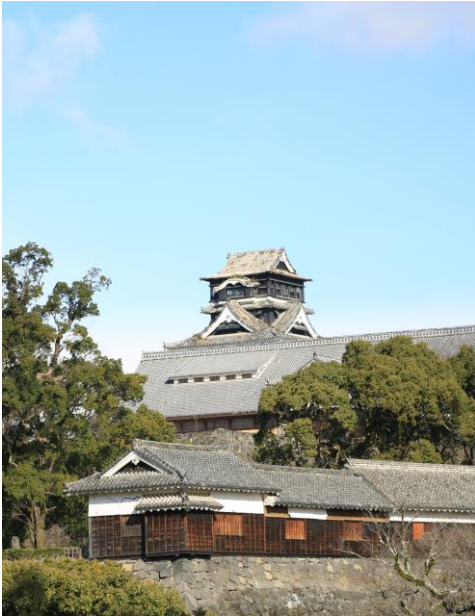
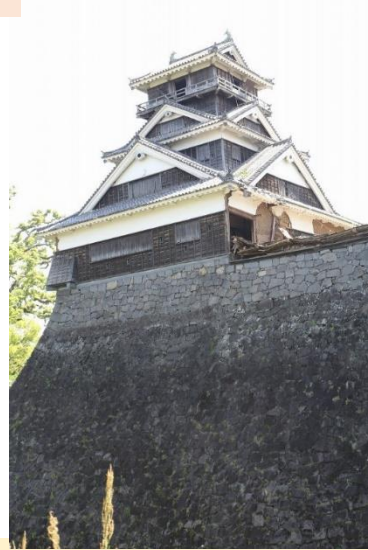
A watch tower-not so much damaged (original, 1601)

Collapsed castle tower (reconstruction, 1960)

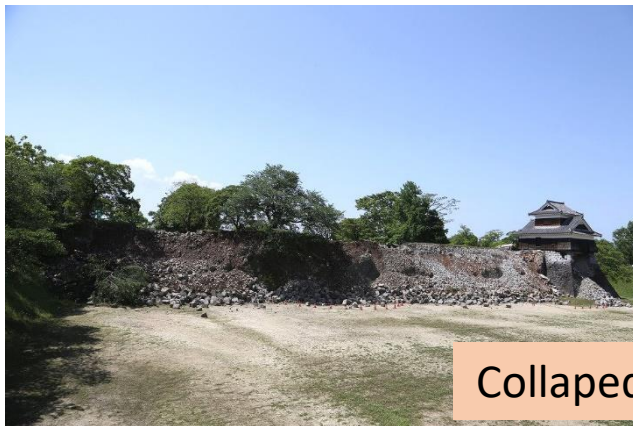
Collapsed castle stone wall

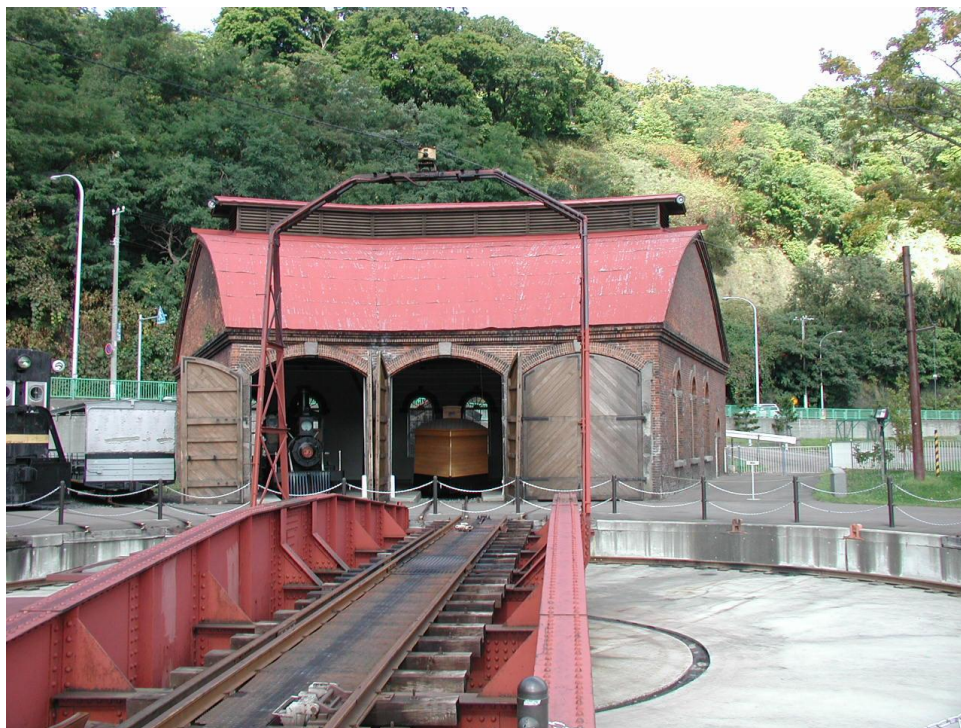
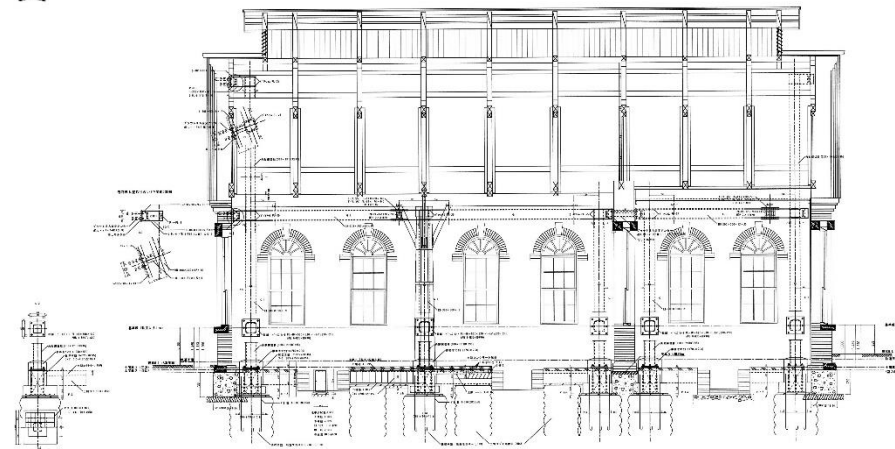
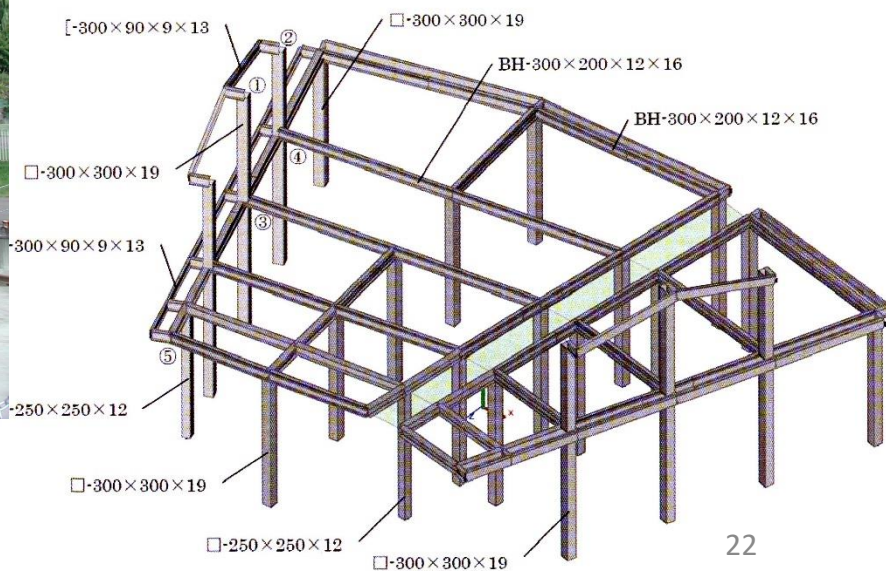
Seismic Reinforcement with Steel Structure

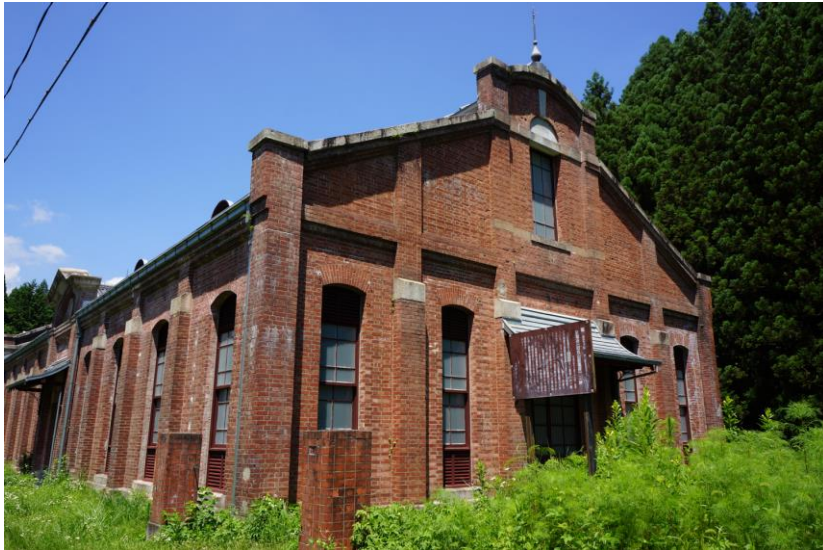
Foundation reinforcement,
steel reinforced beams and columns

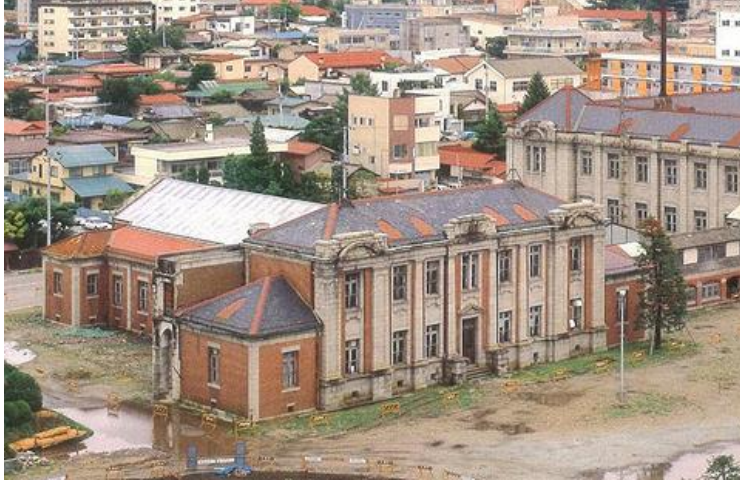
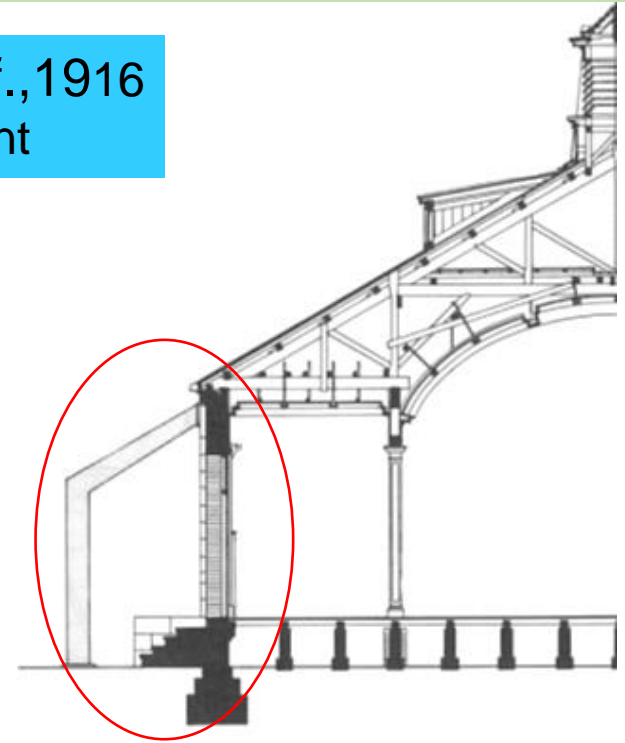
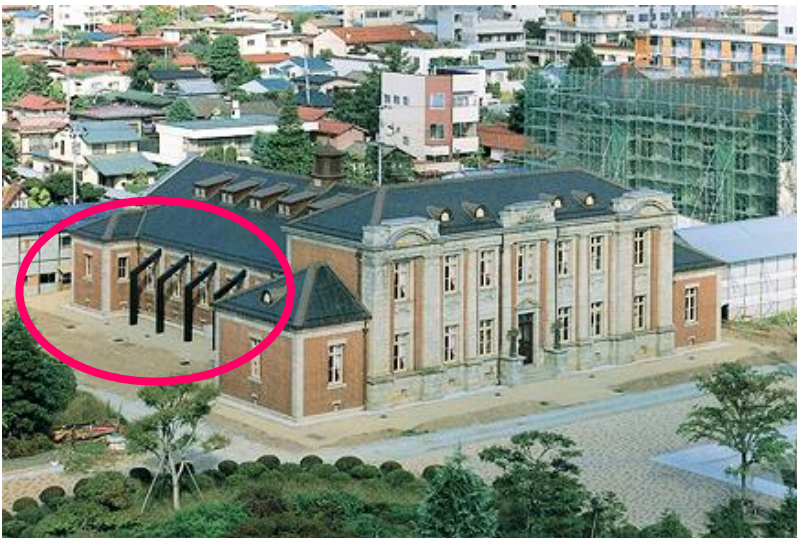
Exterior buttresses added to restore beautiful interiors and provide seismic reinforcement

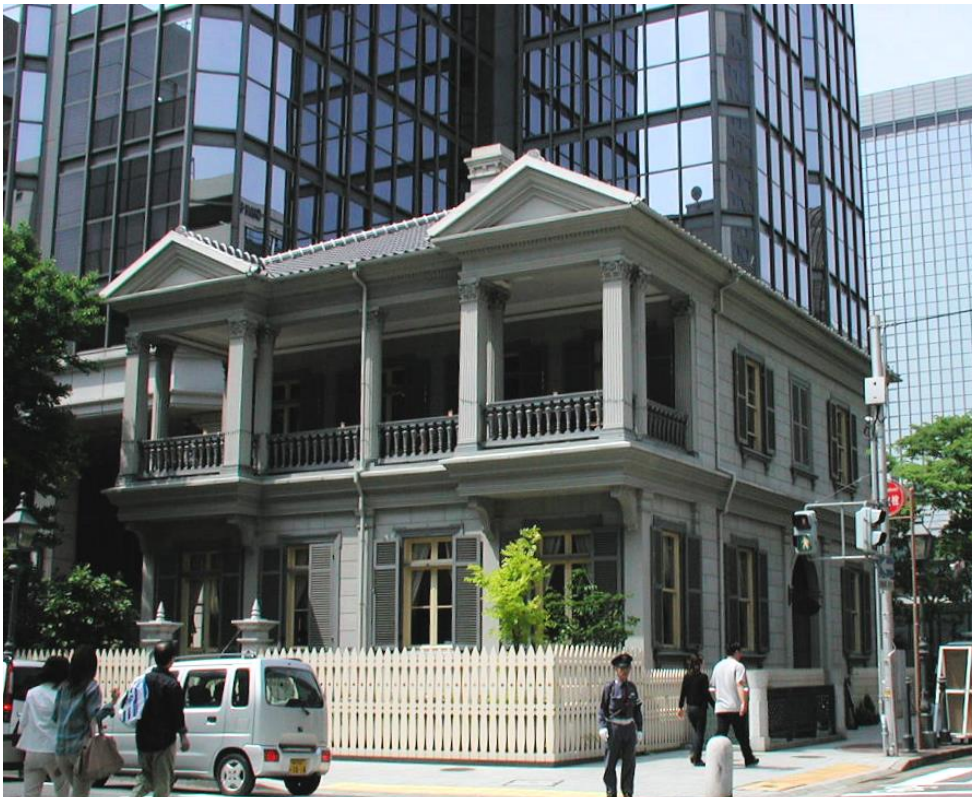
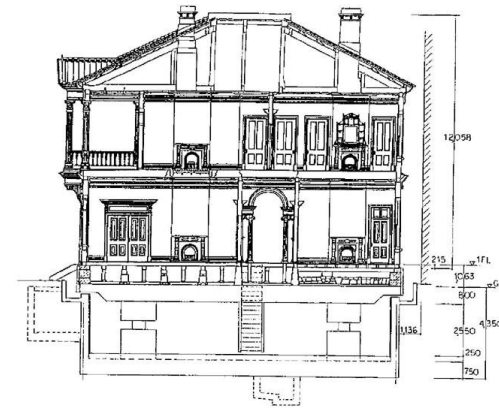
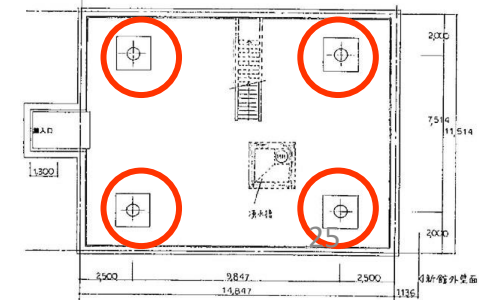
- 1995 Collaped by Hanshin-Awaji Great Earthquake
- 70% of damaged materials were reused for repairment
- 1998 Seismic isolation method secures earthquake resistance

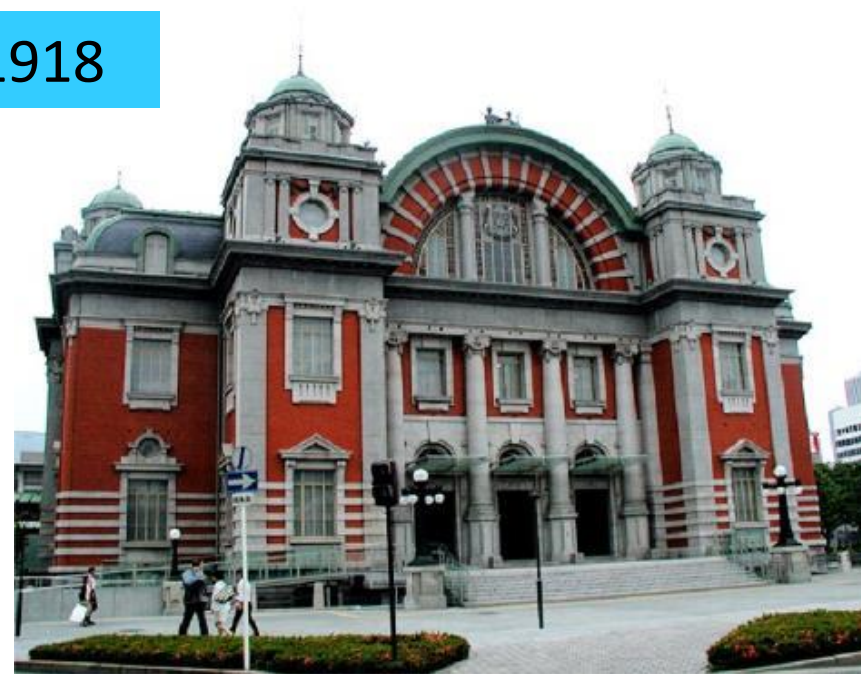
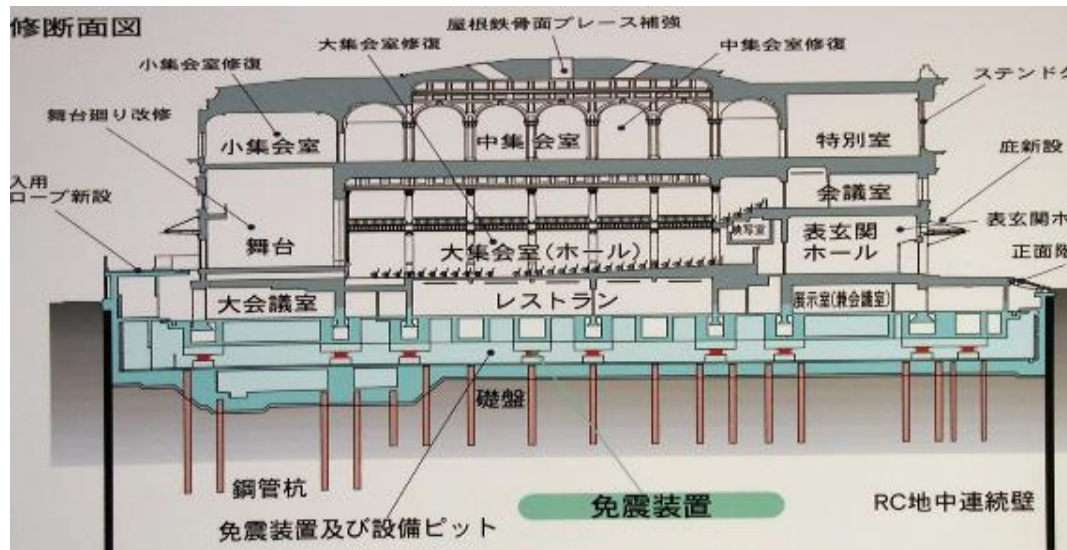
Conservation and revitalization Project
1999~2002
" Seismic isolation retrofit work"

Seismic isolation devices were installed in the basement of the building.

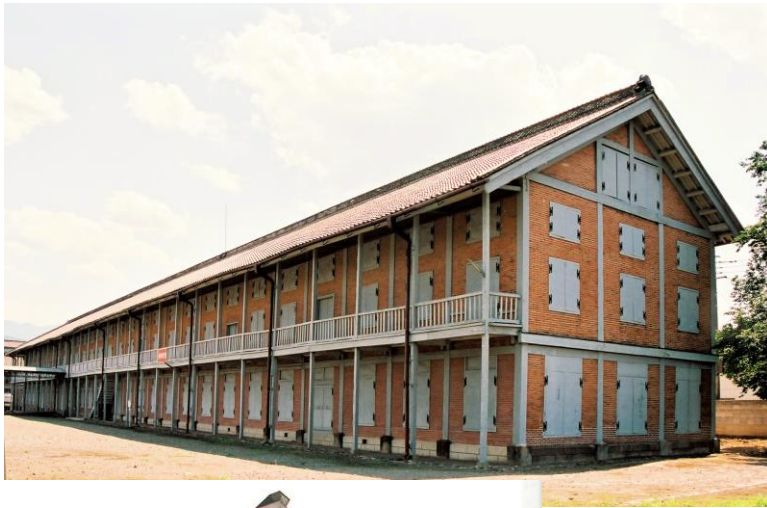
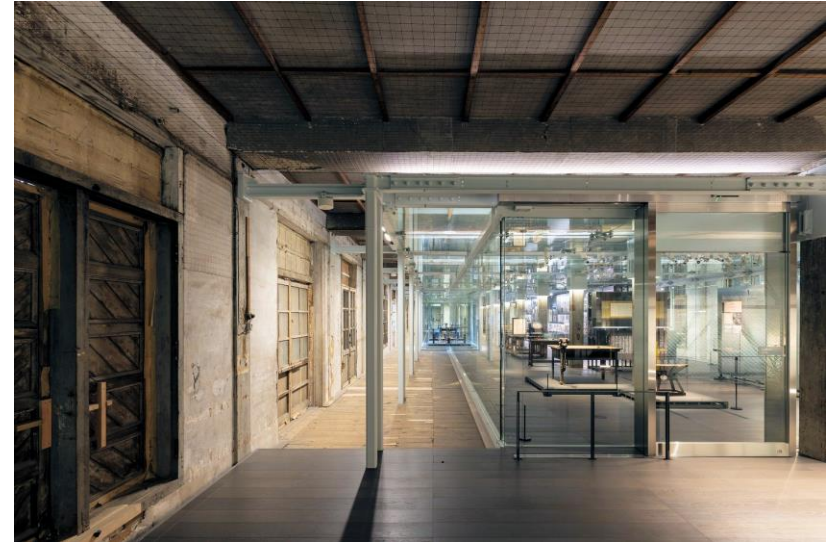
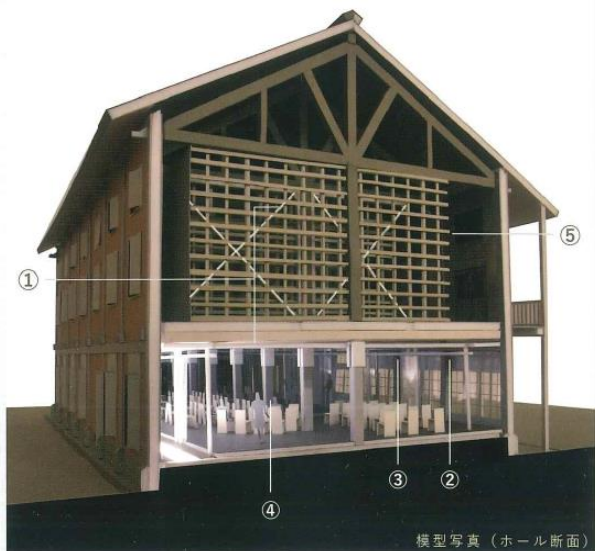
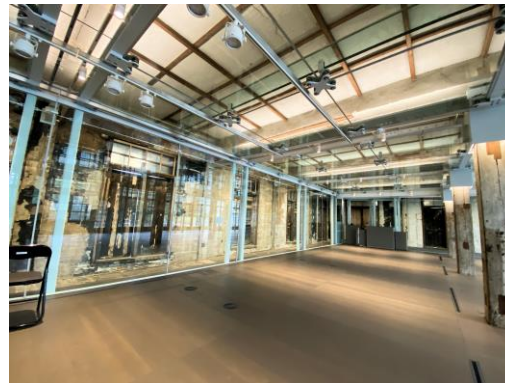
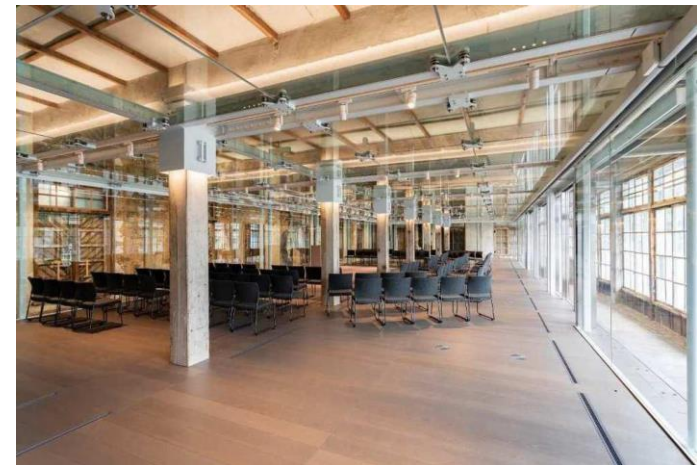
Repairment, seismic reinforcement, utilization using **House-in-House** method
The west cocoon warehouse of Tomioka Silk Mill, 1872, Gunma Pref.

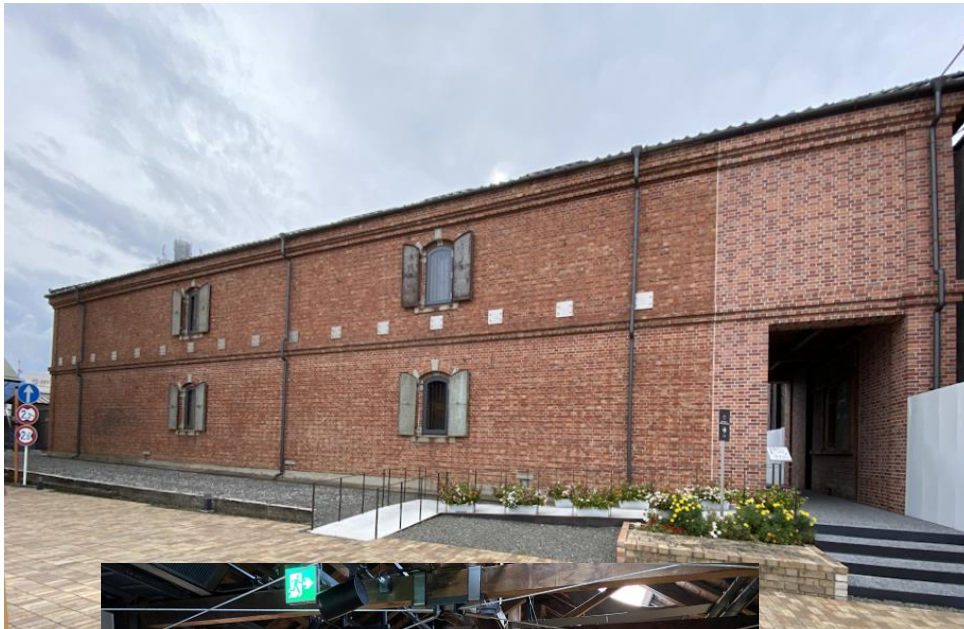
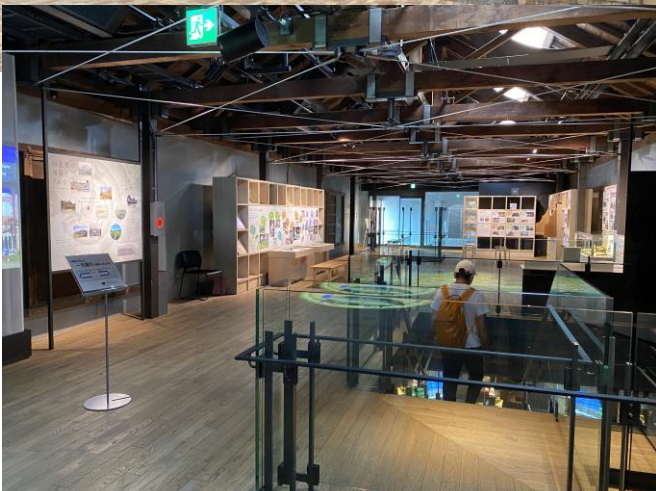
Old brick warehouse, 1903, was renovated and reinforced to use as the visitor center.
